Bulletin No.: PI1366

Service Bulletin

Subject: Malfunction Indicator Lamp (MIL) Due to DTC P0299 – Loss of Turbocharger Boost

Models: 2013-2015 Buick Encore
2011-2015 Chevrolet Cruze
2013-2015 Chevrolet Sonic, Trax
Equipped with 1.4L Engine (RPOs LUJ, LUV)

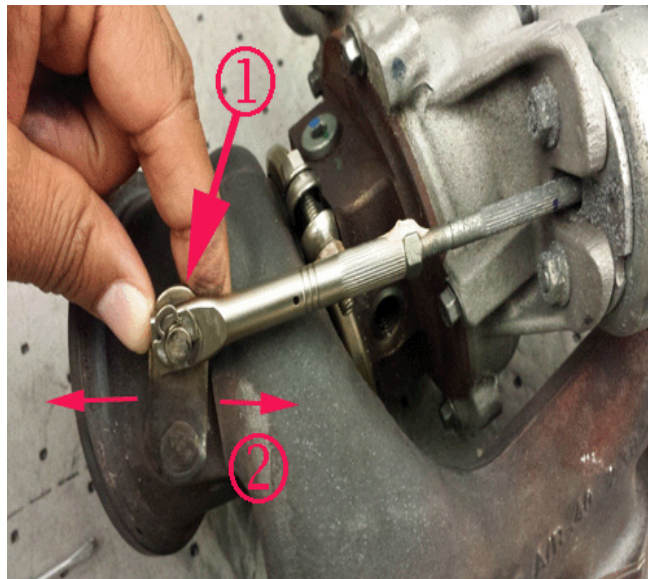
4002329

2. Ensure that the retention clip (1) is in place. If the clip is missing, install a new clip.
3. Use your fingers to wiggle the wastegate pivot lever (1) back and forth.

4. If the lever wiggles with little effort while the actuator rod remains static, the pre-load is insufficient.
5. If the inspection failed, replace the turbocharger. Refer to the Turbocharger Replacement in SI.
6. If the inspection passed, continue diagnoses. Refer to the code P0229 in SI.
